ACOUSTIC CLEANING OF REGENERATIVE AIRHEATERS SUBJECTED TO PRB ASH

Mel Freund
Advanced Acoustic Technologies, LLC
Monkton, MD

Randy Vann
Xcel Energy, Roy Tolk Station
Muleshoe, TX

Fourth Intelligent Sootblowing Workshop

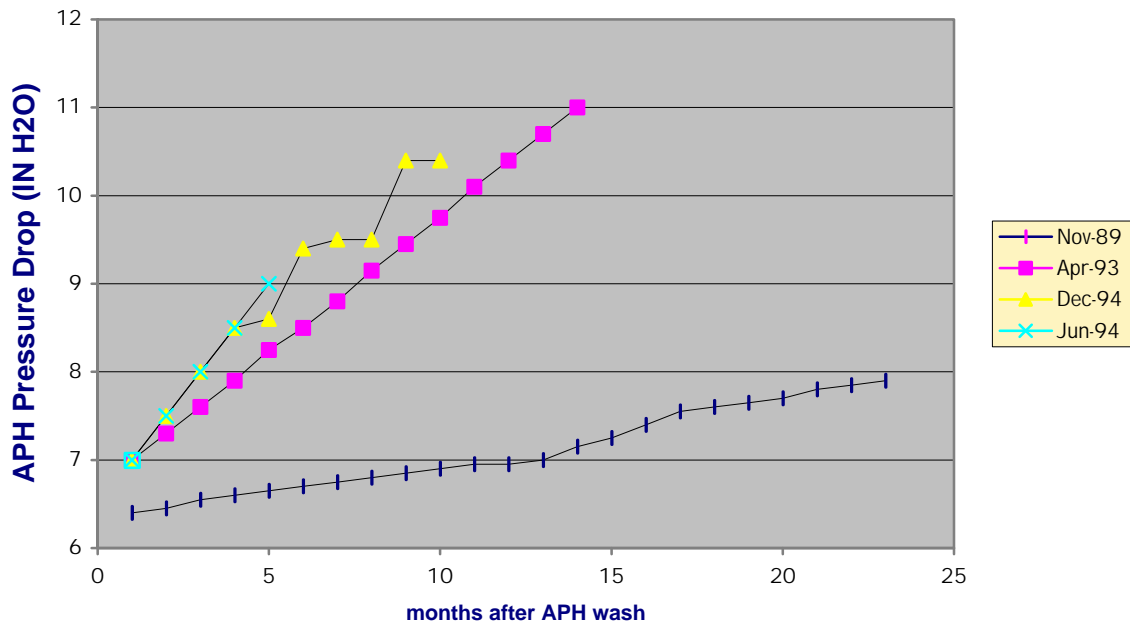
Fig 2 - Tolk Station - 535 MW

With fuels other than PRB, air heater element replacement has generally come when the metal has been eroded by sootblowing, or when the temperature cycles on the elements are numerous enough to cause failure. With PRB ash, however, the elements become unusable when they have accumulated enough "cement". This phenomenon is clearly demonstrated by plant data, see **Figure 2** for details.

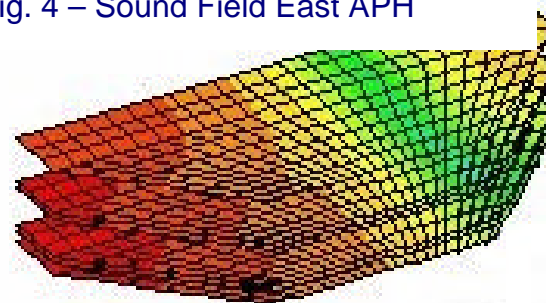
Fig. 4 – Sound Field East APH

Figure 4 shows the sound levels for different frequencies of injected sound energy. The sound frequency that provides the most efficient utilization of energy to produce the required cleaning is the one that is chosen. Because of these results, the original location and frequency chosen for the first three infrasonic cleaners were retained for the fourth and final application.

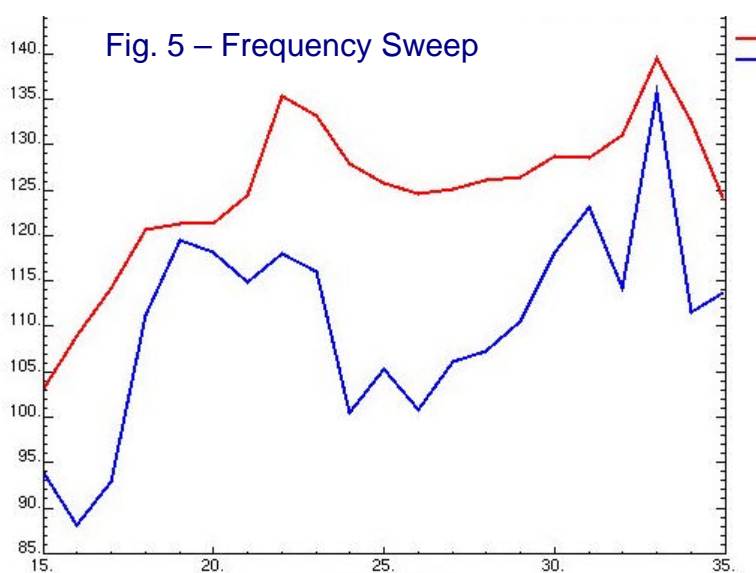
Figure 5 shows the sound levels at the boundaries of the different element layers within the air heaters. One of the benefits of Ljungstrom type air heaters is that small areas of low sound levels will not adversely affect cleaning. Because the elements are constantly moving, if the sound level is low one moment, it will increase the next moment.
