## **Deely Information**

#### Air Preheater / Staggered Economizer "Cleaning Challenges"

### Solution to Pluggage Problem

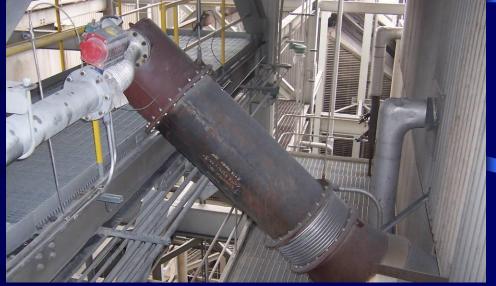
### Acoustic Cleaning Hardware

#### 2003 Unit 2:

- 2 ea on Economizer

#### 2005 Unit 1:

- 2 ea on Economizer
- 1 ea on Air Preheater

### 2006 Unit 2:

1 ea on Air Preheater

Location and Frequency of acoustic cleaners were determined by 3D finite element modeling

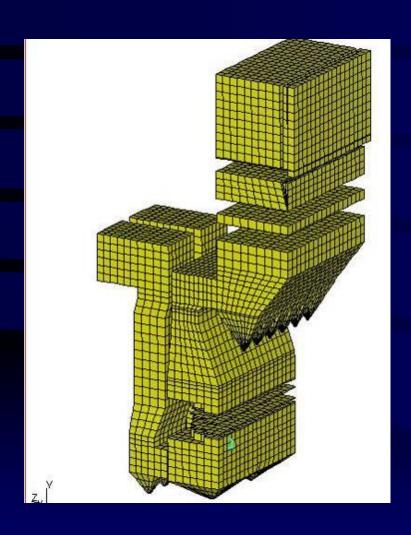
### **Acoustic Modeling**

- Cleaning Application modeled in 3D with FEanalysis
- Frequency gets selected that has the best cleaning characteristics and best response in application
- Installation location gets optimized for uniform coverage
